Case Study – A ‘Reel’ disassembly challenge - The vacuum cleaner

Peter Dobson, Ali Buchanan, Scott Keiller & Martin Charter

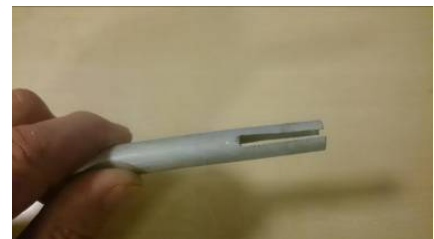
After some consideration it was decided a ‘tool’ would need to be made to get the two halves of the reel drum apart to access the cable termination. This was achieved by cutting two grooves into an odd piece of aluminium piping which happened to be exactly the right size.

The home-made ‘pawl opening tool’ was inserted inside the centre of the drum assembly to pull the four plastic pawls apart to allow the two halves of the drum to be separated.

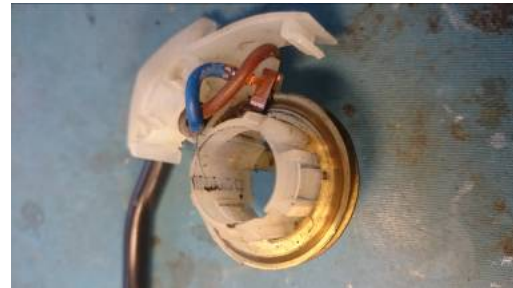
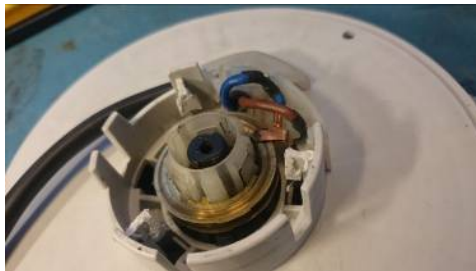
Once the reel drum had been taken apart the damaged section of cable was cut out, but to re-terminate the cable it had to be connected to the existing crimp pins used on the slip ring assembly. In the picture on the right the damaged cable is just out of shot.

The cable was cut about 20mm from the slip ring crimp pins and an in-line solder joint was made up and covered with heat-shrink sleeving. The in-line joints are not subject to stress because they are downstream from the cable clamp.
