Case Study: Repair to Kodak Carousel Projector

Peter Dobson

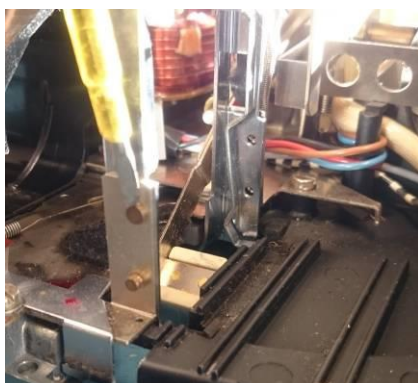
The picture shows the two peened rivets on the other side of the slide frame which are still in place, as indicated by the yellow sleeved screw driver blade.

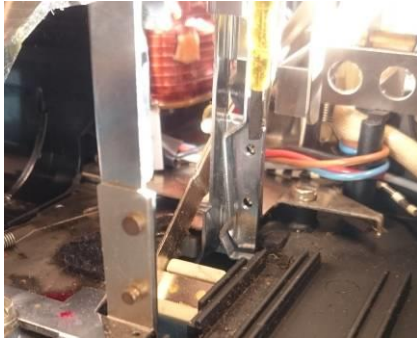
Repair. The arm was re-bent straight but this did not in itself cure the problem. Next it was found that the slide guide frame had become detached from the main projector frame because two 2mm peened rivets had come undone.

This picture shows (with the screw drive blade the two rivets which have popped out).

This was difficult to fix. In the end it was decided to drill out the lower rivets and fit an M2.5 countersunk bolt and nut. The upper rivet was left in place as it carried a spring associated with the clamp mechanism.

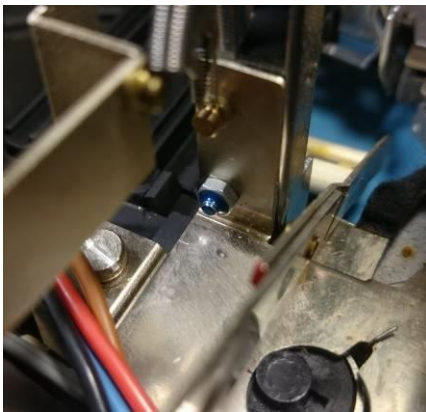
Above the nut is the other brass peened rivet carrying the spring can be seen.

To ensure that the M2.5 nut and bolt won't come undo Loctite 243 (blue) was used to lock the nut threads in place. This should ensure a long lasting repair but if really necessary the nut can be removed by unlocking the Loctite with a heat gun.

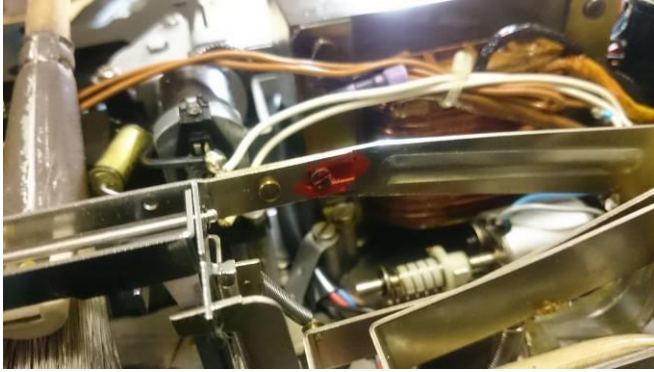
Close inspection showed that the slides were not being lifted fully out of the projector before the carousel was indexed to the next slide. This was traced to the original slide arm which whilst having been bent straight was now not lifting the slides correctly. This was corrected by adjusting the offset cam on the slide arm (red caped screw). This adjustment was very sensitive and took several attempts to get it right.
